ATTACHMENT TO L-4926 13 MARCH 1968

FIRST AIRCRAFT AT BAI THUONG AIRFIELD NORTH VIETNAM 195405N 1052732E

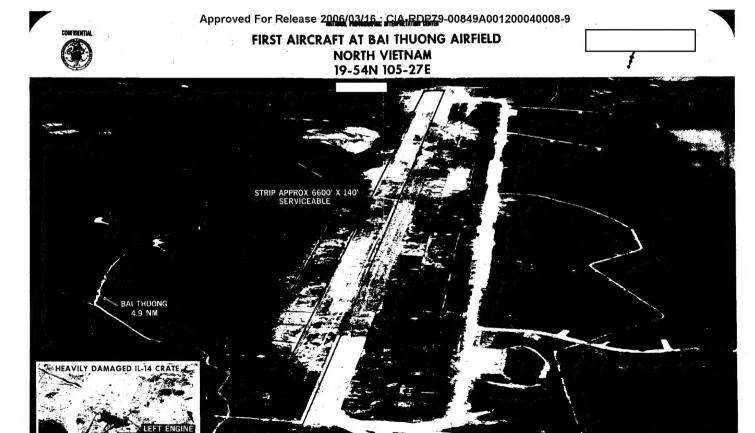
NPIC L-4926 [3/68]

REVEALS A HEAVILY DAMAGED AND CAMOUFLAGED IL-14 (CRATE) TRANSPORT AIRCRAFT AT THE NORTH END OF THE LANDING IT APPEARS THE AIRCRAFT ATTEMPTED A LANDING ON THE NATURAL SURFACE STRIP (APPROXIMATELY 6600 FT X 140 FT, SERVICEABLE) PARALLELING WAY AND WAS UNABLE TO STOP BEFORE REACHING THE END OF THE STRIP. SCARS INDICATE THAT THE AIRCRAFT APPARENTLY SKIDDED OFF THE NORTH END OF

(c) NATIONAL PHOTOGRAPHIC INTERPRETATION CENTER REFERENCE: ATTACHMENT TO L-4926 13 MARCH 1968 PAGE 2 THE LANDING STRIP AND CAME TO REST PERPENDICULAR TO IT. THE AIRCRAFT FUSELAGE IS ON THE GROUND WHICH INDICATES THE LANDING GEAR IS UP OR WAS DAMAGED DURING THE LANDING. THE TAIL SECTION APPEARS TO HAVE BEEN

DAMAGED DURING THE LANDING OR IT HAS BEEN REMOVED FOR REPAIRS.

LEFT ENGINE ALSO APPEARS DAMAGED.
